Manhole Inspection Summary

Manhole # S17GG1011MH

Location Address: **4104 GREENSPRING AVE**

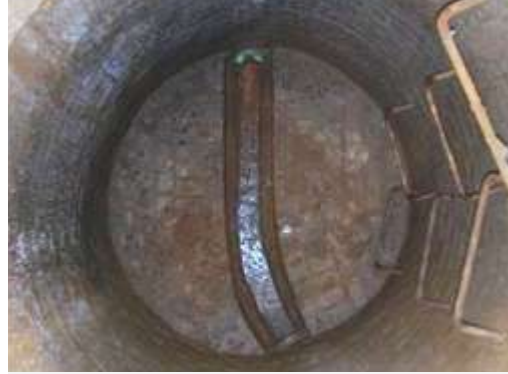
Top View

Evidence of surcharge - Bench debris.

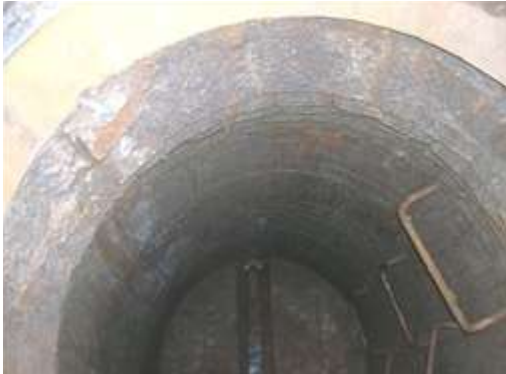
Defect

Frame leaks. Adjustment deterioration and infiltration. Corbel and Barrel infiltration.

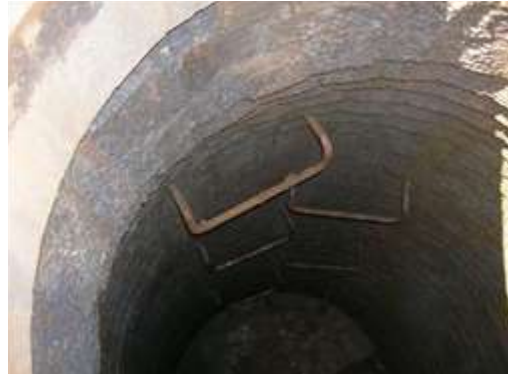
Defect

Frame leaks. Adjustment deterioration and infiltration. Corbel and Barrel infiltration - other side.

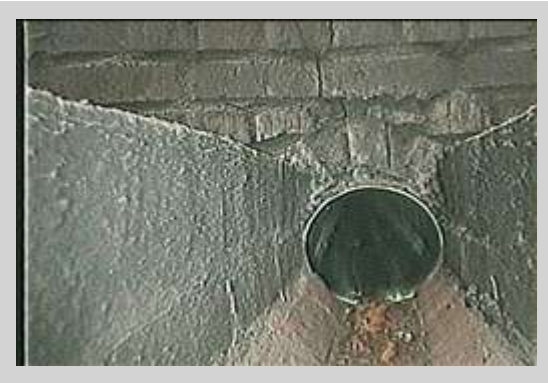
8 in. Circular Gravity Sewer Pipe Out @ 12 O'Clock

Barrel cracks.

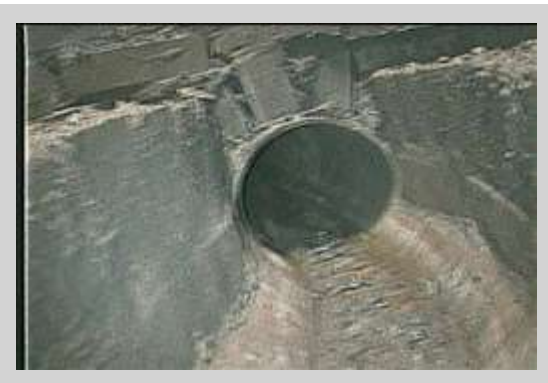
8 in. Circular Gravity Sewer Pipe In @ 5 O'Clock

Barrel deterioration and infiltration. Channel deterioration.
